LONGFORD LAKE DAM

NDI ID NO. PA-00898,
DER ID NO. 58-137

PHASE I INSPECTION REPORT NATIONAL DAM INSPECTION PROGRAM

SEPTEMBER 1981

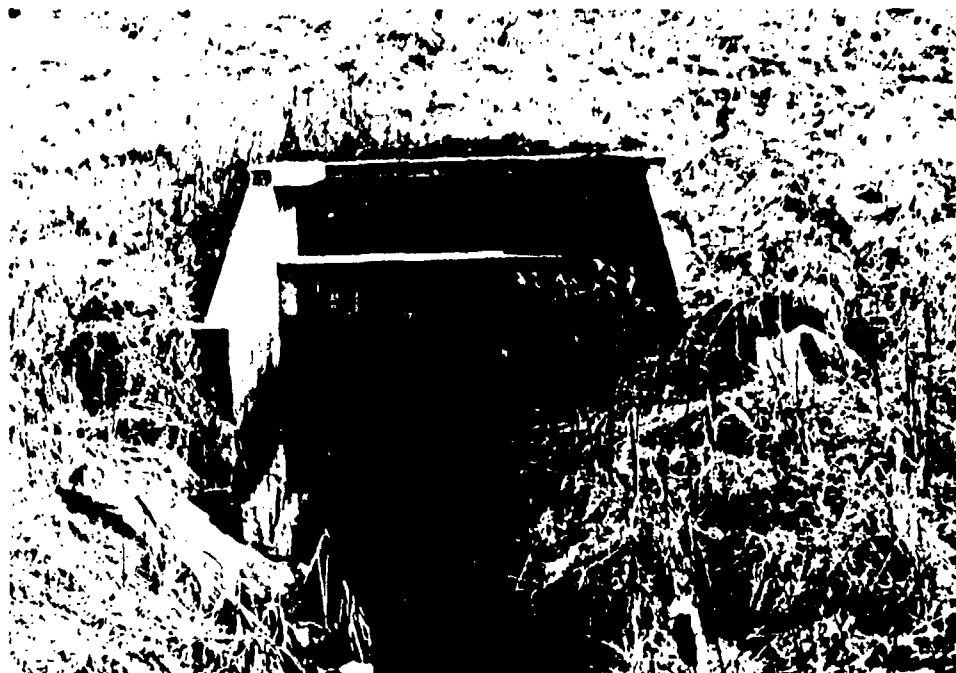
7. Impact-type energy dissipator at discharge end of conduit.

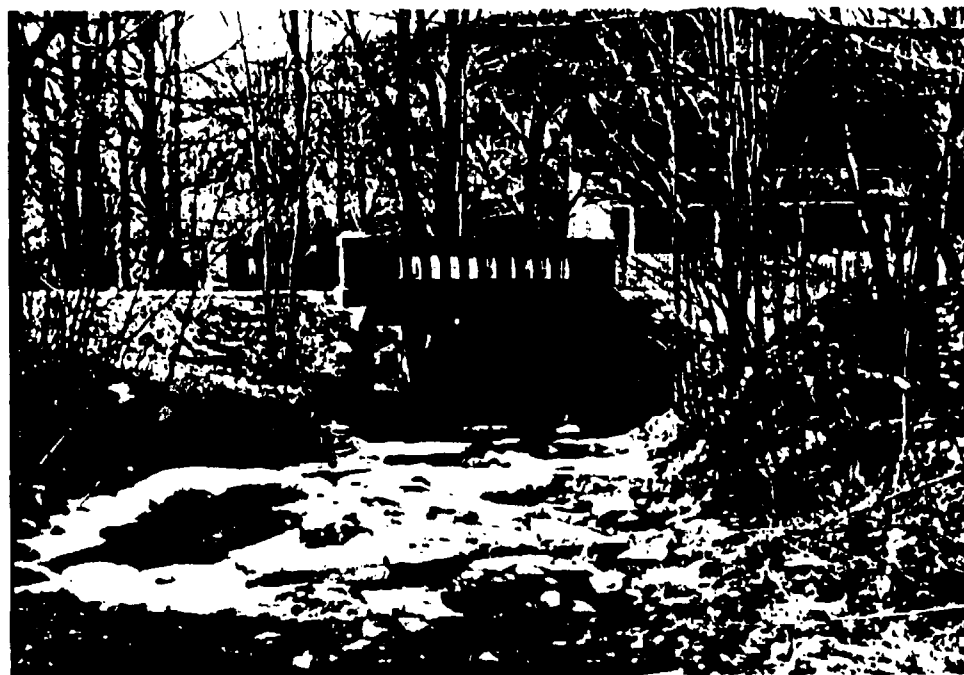
8. First downstream hazard (2 miles downstream).
Pennsylvania Route 267 bridge is in center of picture.

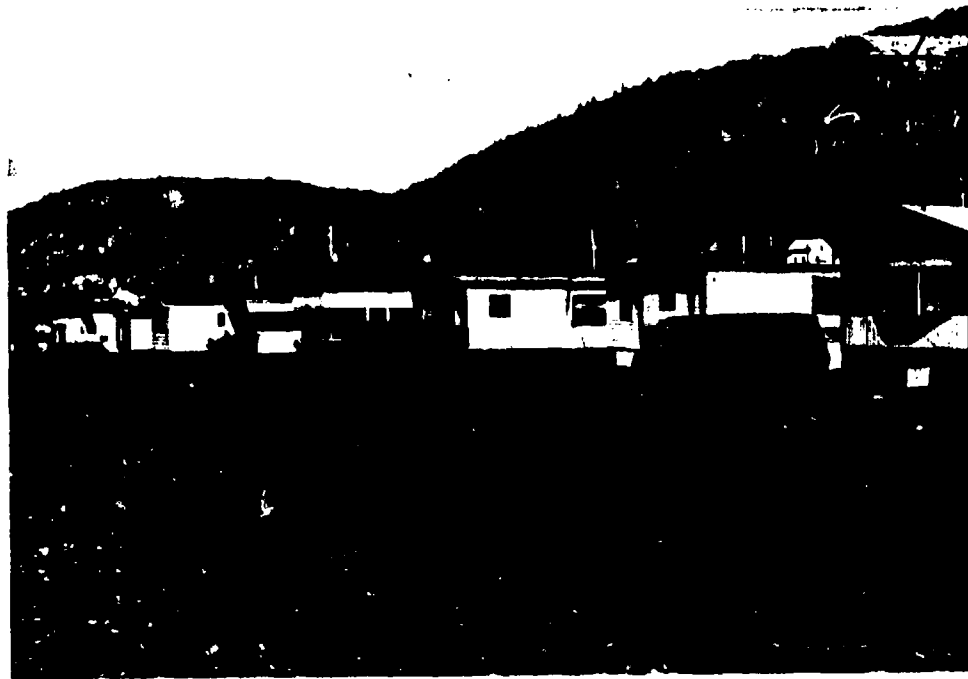
9. Trailer park which constitutes second downstream hazard.

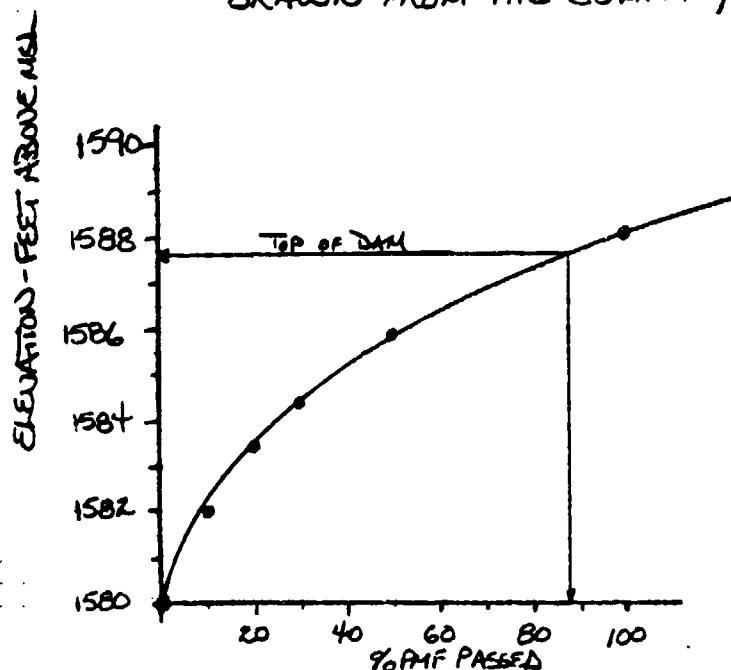
LONGFORD LAKE DAM CAN PASS
88% OF THE PMF PRIOR TO
OVERTOPPING THE EMBANKMENT.

THIS FACILITY CAN CONTROL 88% OF THE PMF. AT THE SDF (FULL PMF) THE DAM IS OVERTOPPED TO A MAXIMUM HEIGHT OF 0.51 FEET FOR A TOTAL DURATION OF 2.0 HOURS. SINCE THIS FACILITY CAN PASS 1/2 PMF WITHOUT OVERTOPPING BUT CANNOT PASS THE SDF (FULL PMF), THE SPILLWAY IS RATED AS INADEQUATE. NO BREACH ANALYSIS IS REQUIRED.
